DOE/NASA 0017/2  
NASA CR-165197  
DDA EDR 10383

## **CERAMIC APPLICATIONS IN TURBINE ENGINES**

### **Progress Report for 1 January 1980 to 30 June 1980**

Detroit Diesel Allison Division  
General Motors Corporation

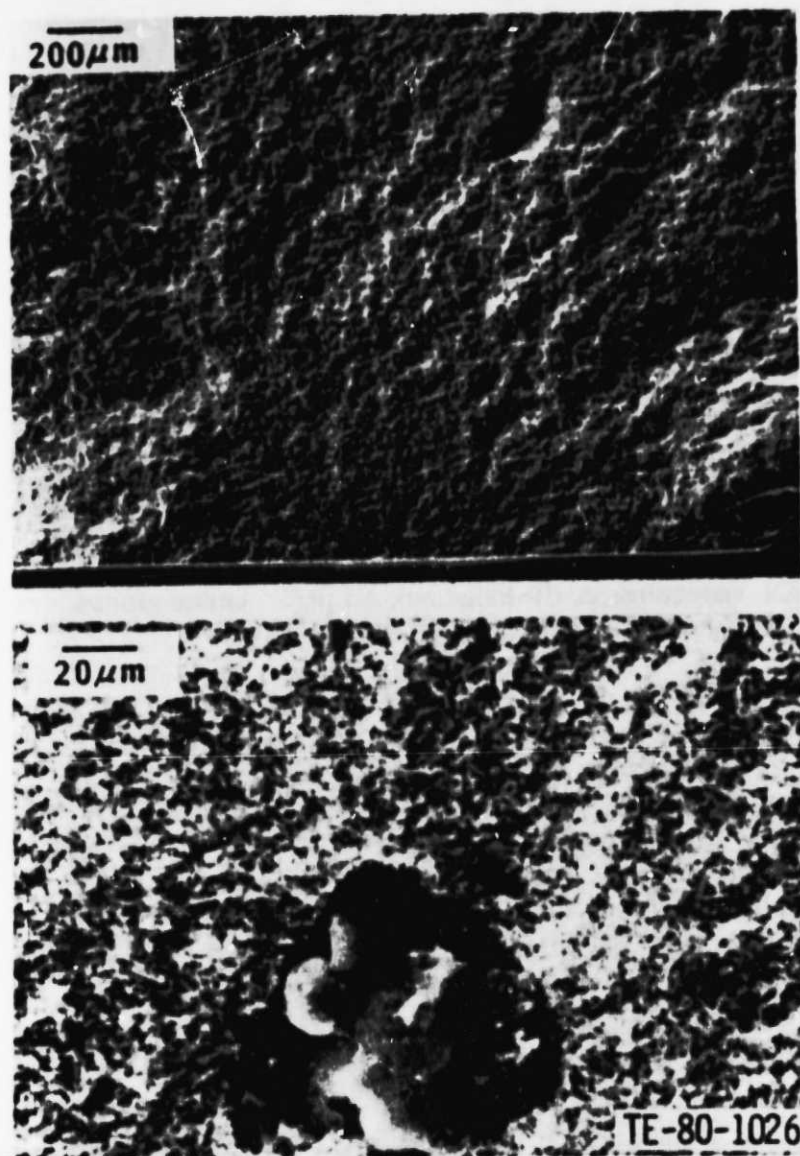
Its average modulus of rupture (MOR) at room temperature was 219.4 MPa (31.82 ksi) with a standard deviation of 17.4 MPa (3.98 ksi). Calcium carbide inclusions, shown in Figure 6, and pores were found to be the strength-controlling defects.

Figure 6. SEM fractograph of NGK-Locke SiC. The critical flaw is a calcium carbide inclusion.

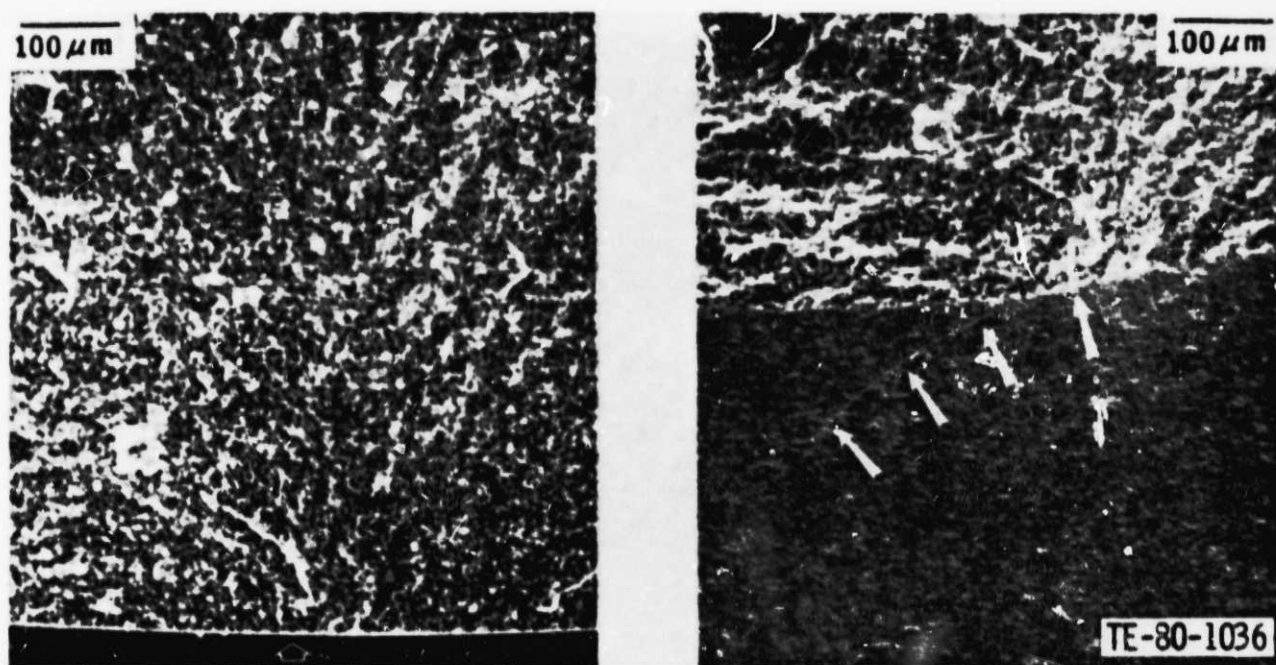
Figure 16. Fracture surface of ground SNW-1000 showing surface scratch at failure origin.

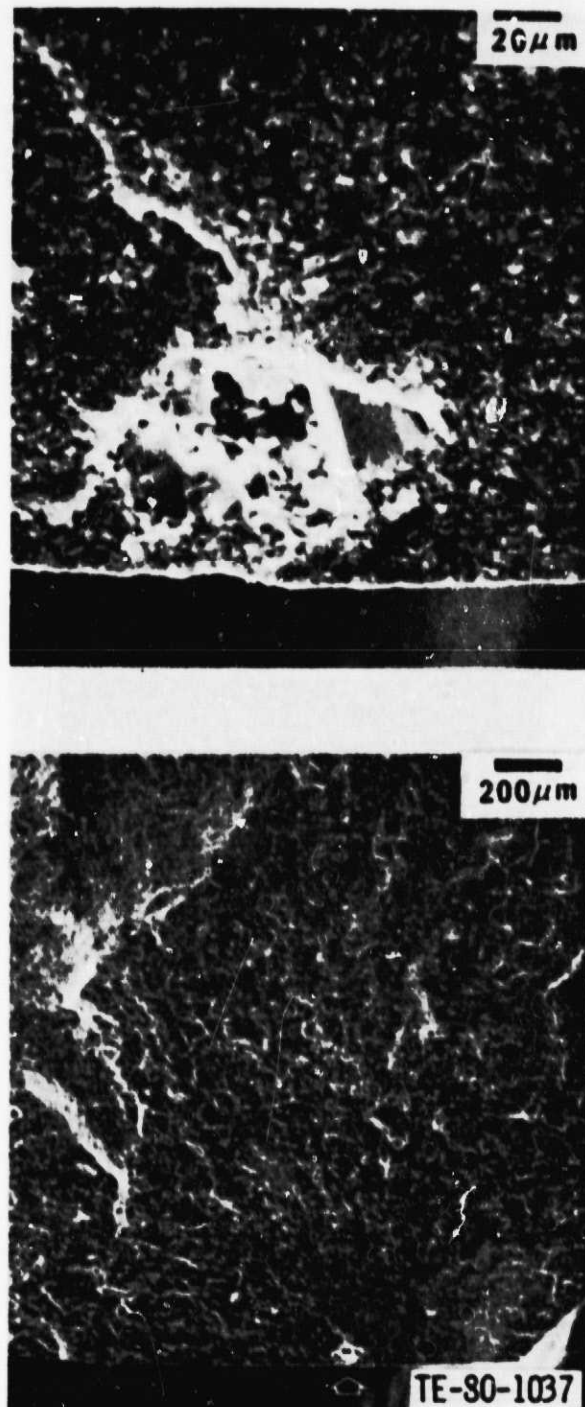
Figure 17. Fracture surface of ground SNW-1000 showing internal pore structure at the failure origin.

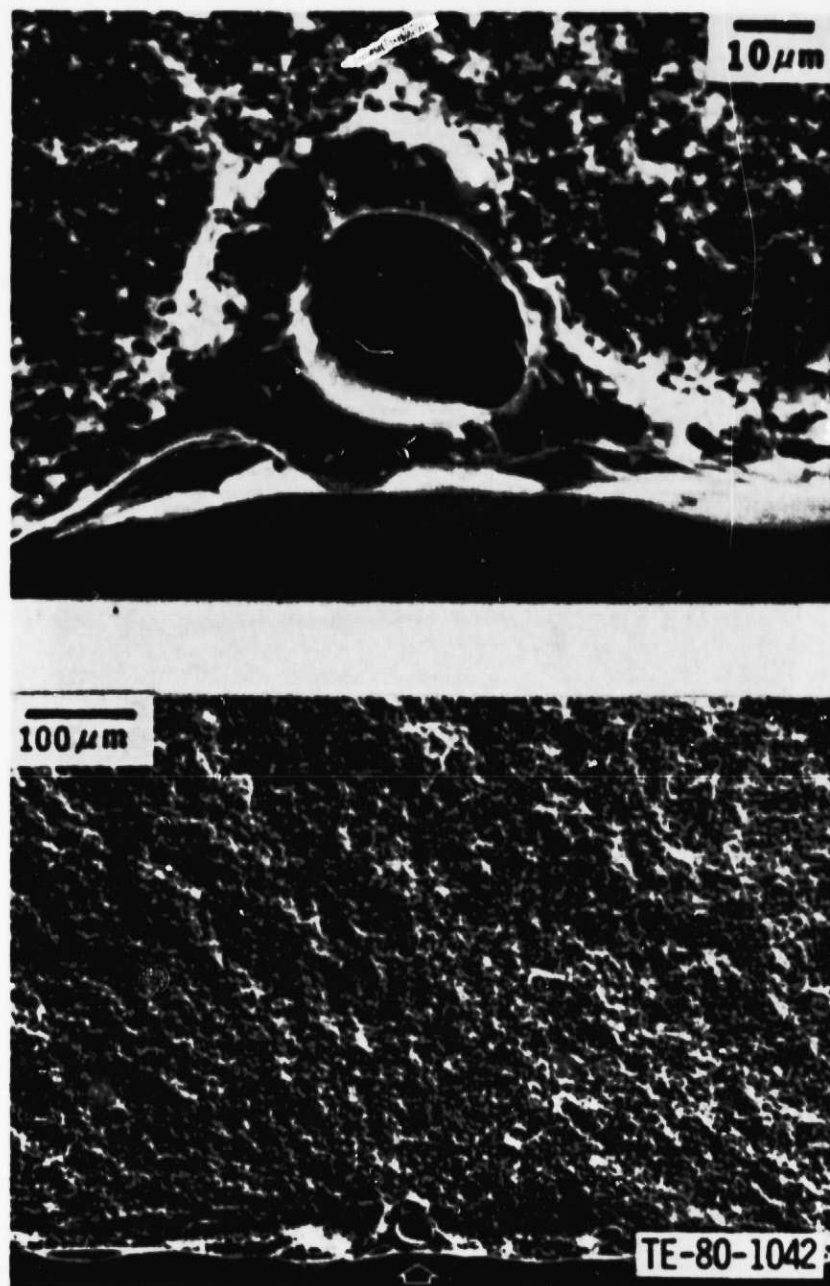
Figure 22. Fractographs of glassy pore and oxide film at the failure origin of as-fired SNW-1000  $\text{Si}_3\text{N}_4$  oxidized at  $1050^\circ\text{C}$  ( $1922^\circ\text{F}$ ) for 100 h.

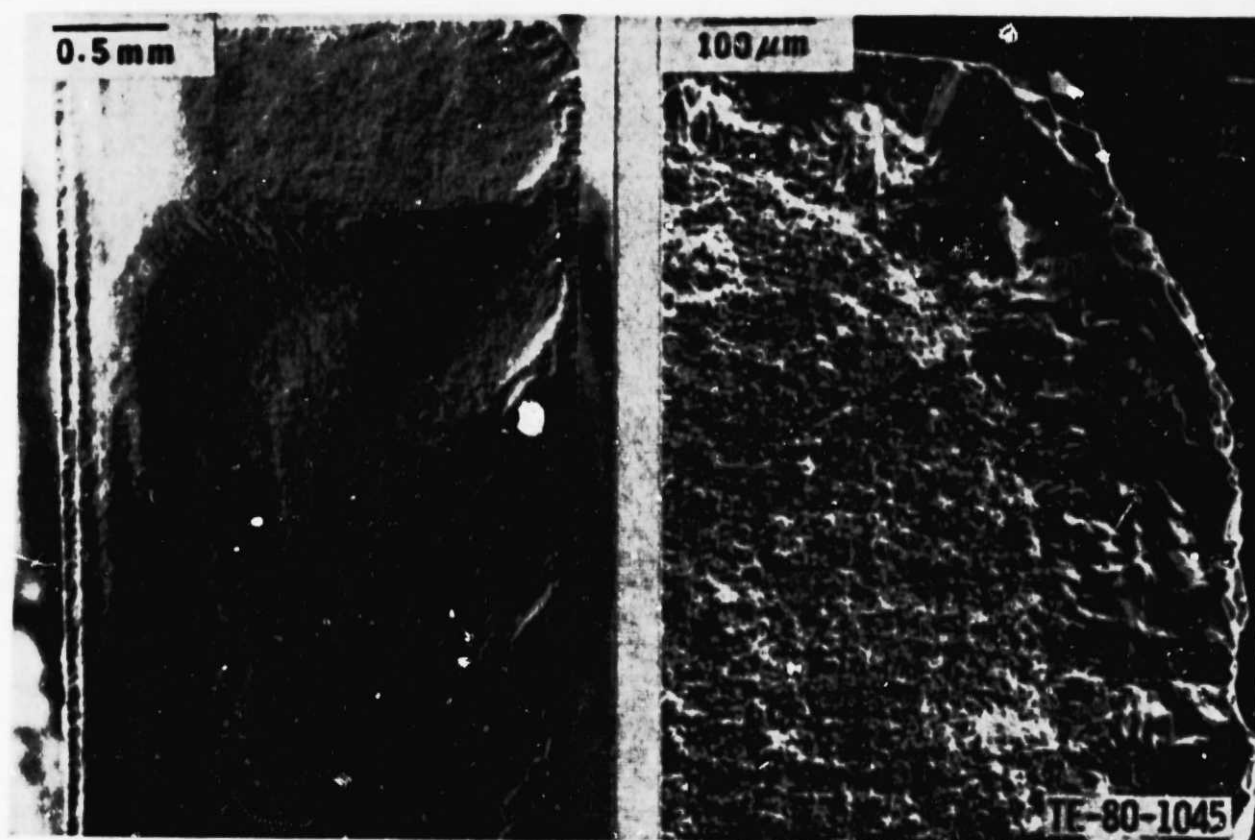
Figure 25. Fractograph of a CVD  $\text{Si}_3\text{N}_4$ -coated RBN-122 bar. Arrow identifies fracture origin.

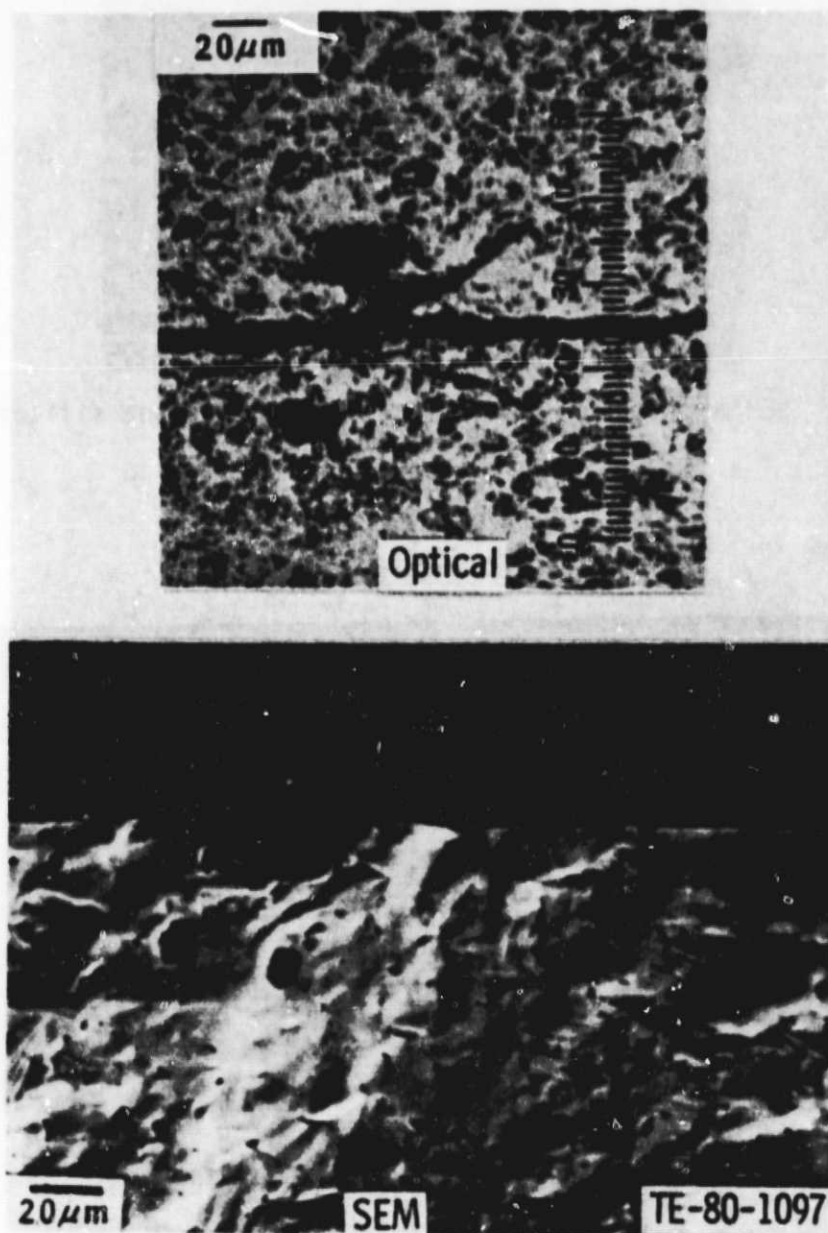
This particular MOR specimen was tested in three-point bending with the indentation at the peak stress location. The fracture strength was 206.8 MPa (30 ksi). Figure 66 shows an optical micrograph of the two mating tensile surfaces and a SEM photograph of the fracture plane at the origin of failure. Failure originated from the polished indentation.

Figure 66. Micrographs of fractured alpha silicon carbide specimen with a microhardness indentation.

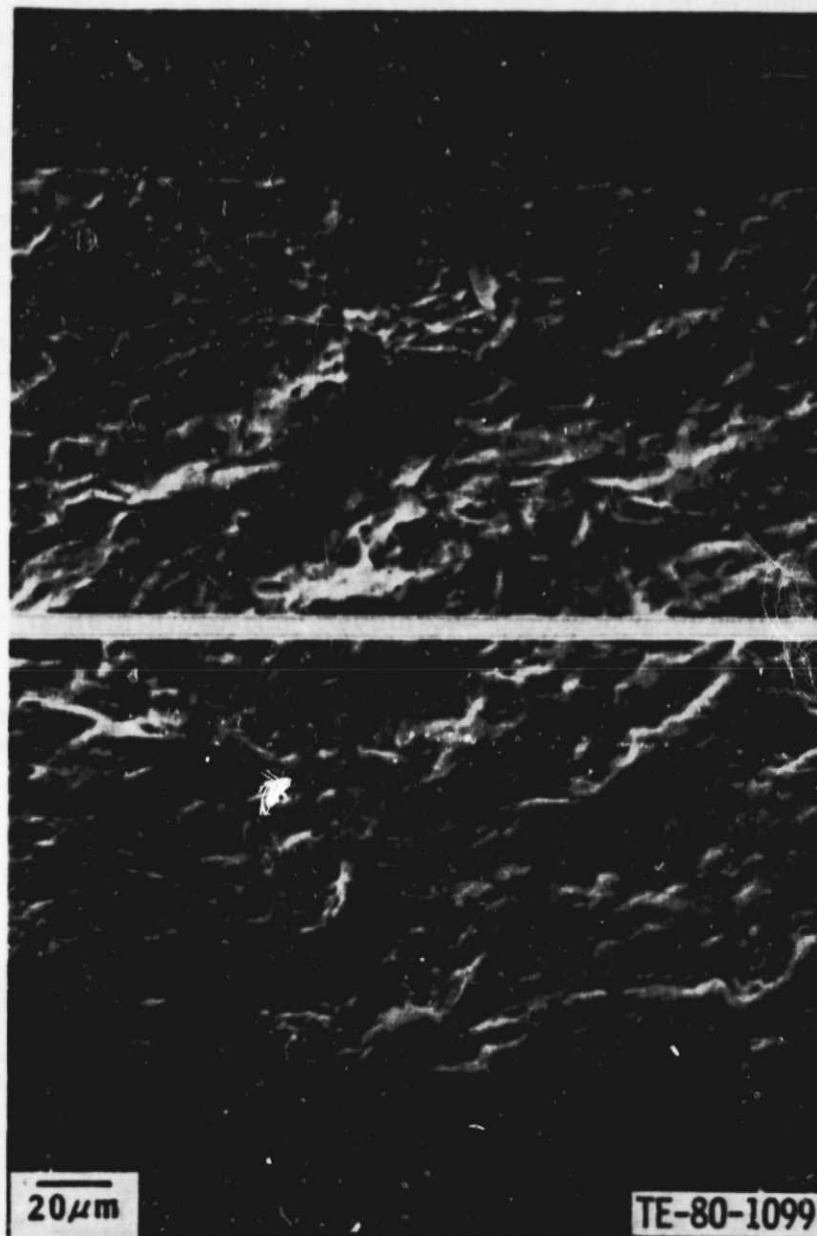
Figure 68. SEM micrograph showing failure origin (pore) in alpha silicon carbide.

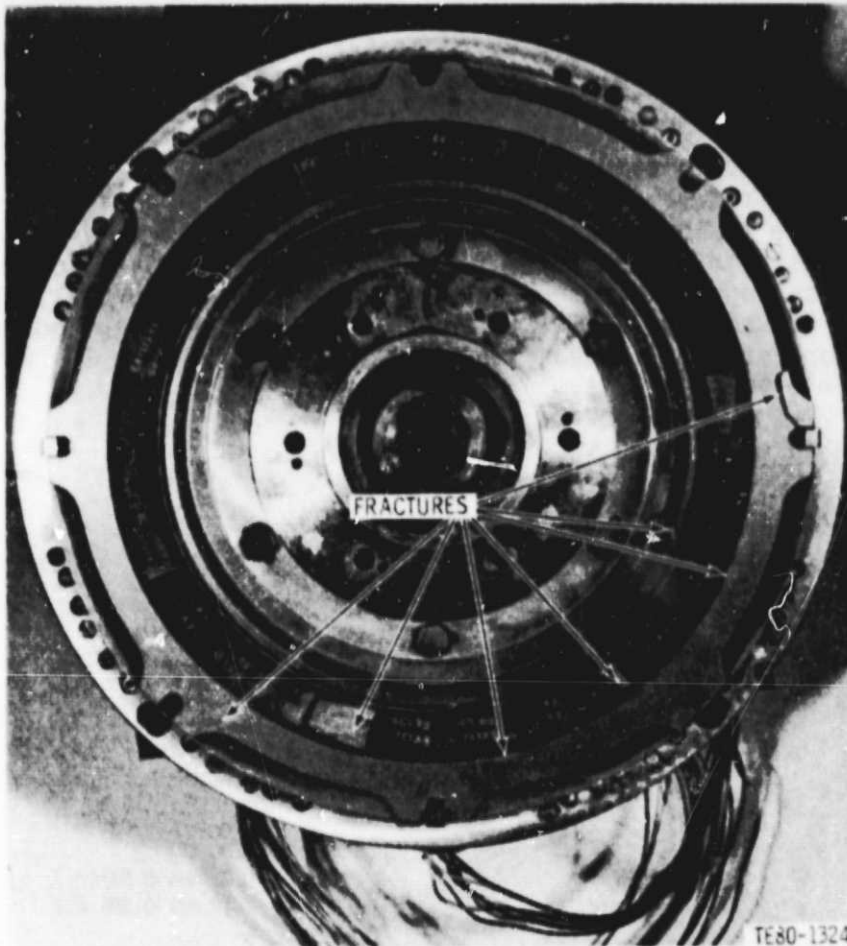
The initial build of the burner rig was conducted in February, see Figures 72 and 73. On the initial rig shakedown run, the thermal cycles were limited from 260 to 582°C (500 to 1250°F) with a peak overshoot to 816°C (1500°F). The gas conditions at both the high and low values were held for a minimum of 5 min to stabilize the temperatures of the ceramic components. After five cycles of these conditions, the nozzle assembly was removed from the rig for inspection. By visual examination, the outer vane support ring was found fractured in three locations, the inner ring was fractured at one point, and two vanes were fractured as shown in Figure 74. Teardown of the nozzle assembly found three more vanes fractured and additional fractures on the outer ring.

Figure 74. 2070°F-configuration gasifier turbine nozzle assembly after rig failure (rear view).

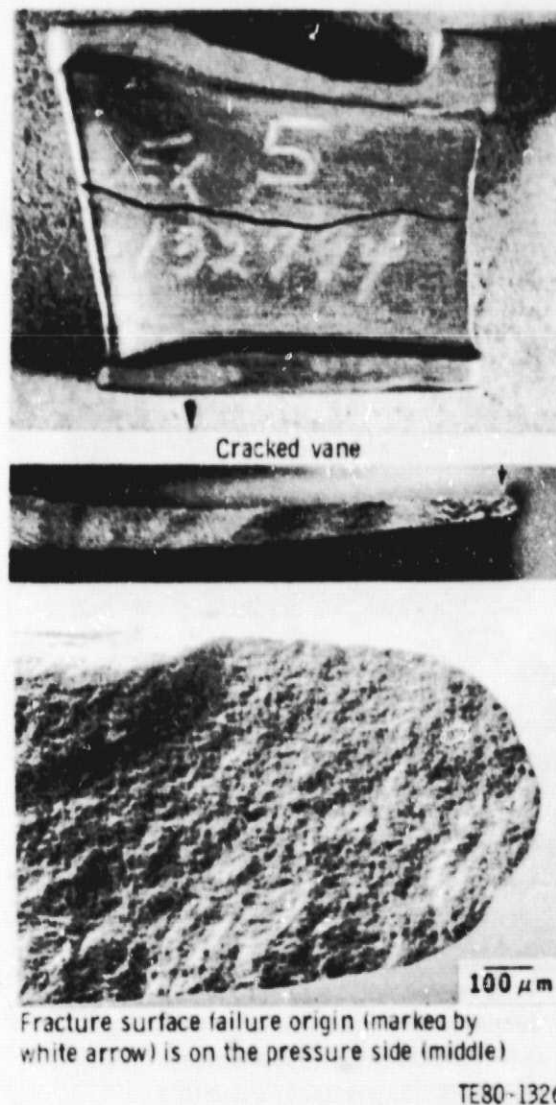
Vane number FX23718 (315 deg CW VFR--Clockwise Viewed From Rear, looking upstream) failed at the midspan section. Fracture was initiated at the trailing edge, pressure side and progressed forward to the leading edge as shown in Figure 76. No obvious flaw could be identified. However, the surface of the airfoil on the pressure side at the failed section contains large grains of silicon carbide.

Figure 76. Failed reaction-bonded silicon carbide vane FX23718 from burner rig thermal proof test.

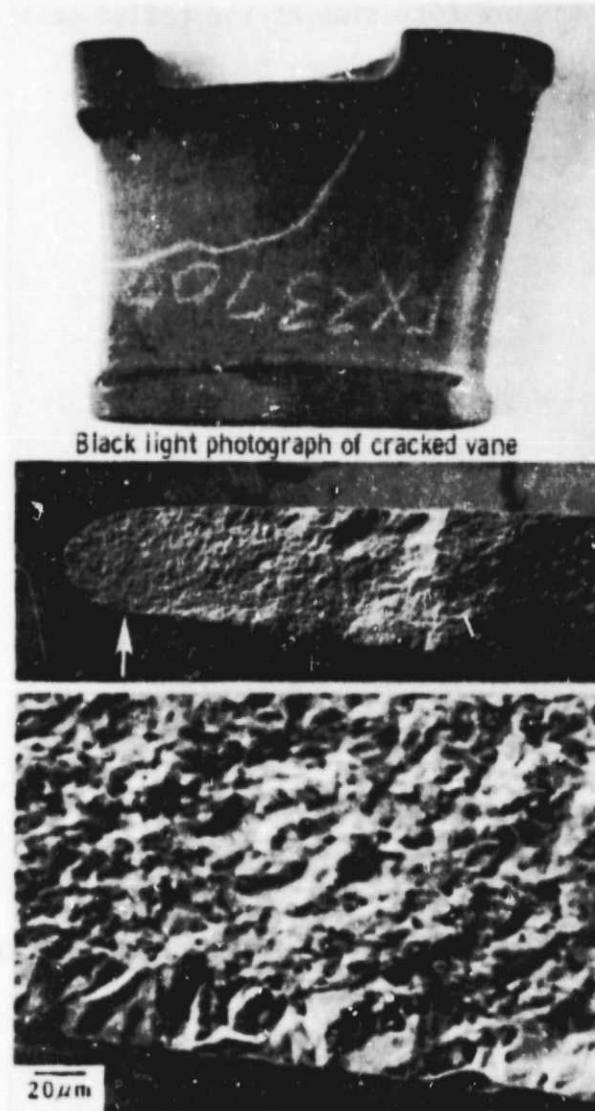
Vane number FX23707 (327 deg CW VFR) also failed from the trailing edge, mid-span location, as shown in Figure 77. No obvious defect could be associated with the failure origin. Again, however, a thin smooth layer of large grains of silicon carbide was present at the surface near the failure origin. While it is not possible to attribute failure directly at this time to the silicon carbide layer, it should be noted that very large granular silicon carbide layers were responsible for thermal shock failures in several early 1900°F-configuration vanes.

Black light photograph of cracked vane

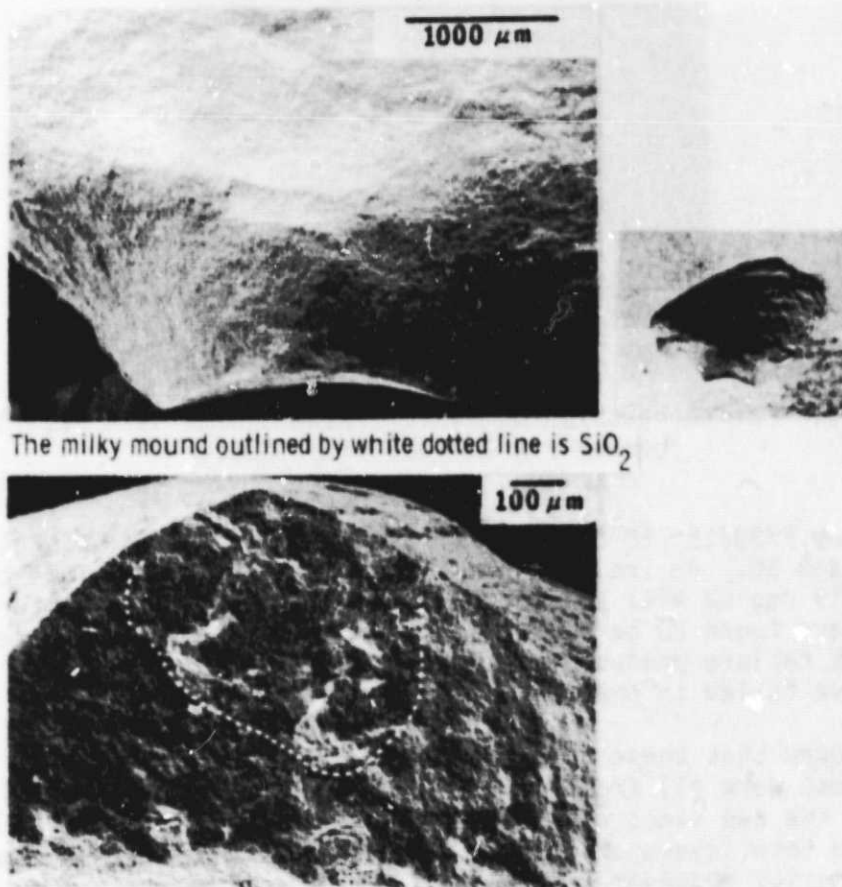
The milky mound outlined by white dotted line is  $\text{SiO}_2$

Figure 78. Spall from No. 4 vane pocket of outer support ring from burner rig thermal proof test.

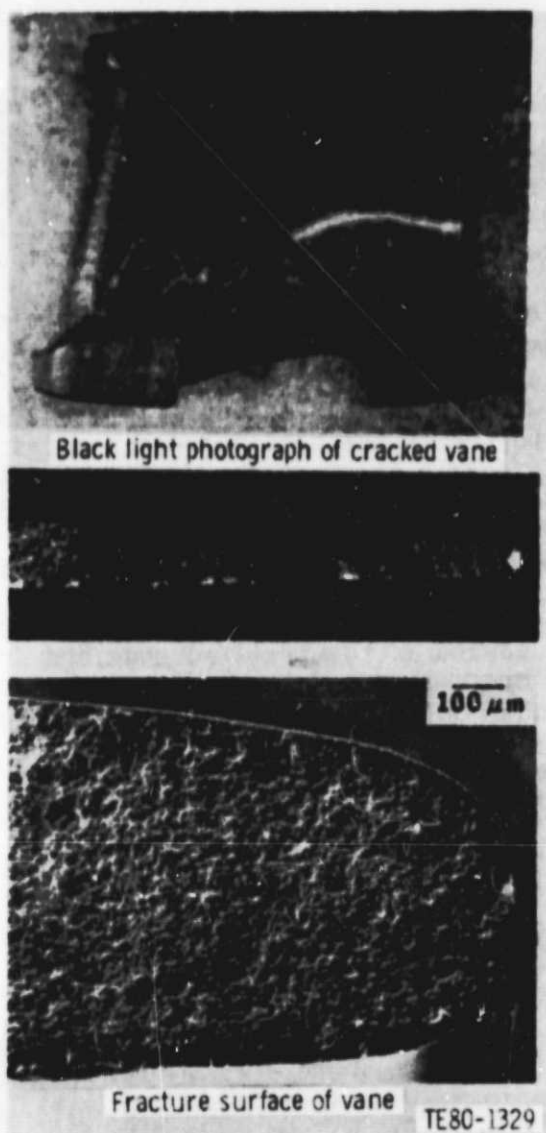
Examination of the three cracked vanes showed that all three failed in a similar fashion. Fracture started at the trailing edge and proceeded forward toward the leading edge along a midspan plane. Arrest occurred at midchord as shown in Figures 79 through 80. No identifiable defect could be found at the

Figure 79. Failed reaction-bonded silicon carbide vane FX23715 from burner rig thermal proof test.

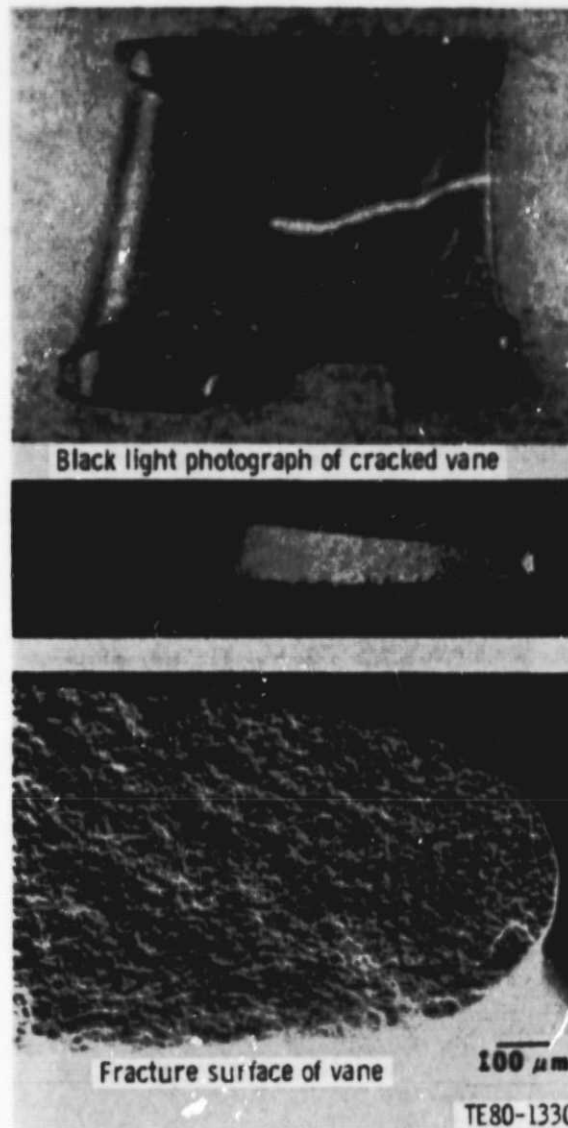
It should be noted that these three cracked vanes as well as the two from the previous rig test were all from the same lot delivered under Task II, Milestone 5. Like the two vanes that failed in the second rig test, both FX23715 and FX23706 had thin layers of silicon carbide on the pressure side of the respective airfoils. However, the present failures appeared to occur directly at the trailing edge where no unusual surface structure existed.

Figure 80. Failed reaction-bonded silicon carbide vane FX23706 from burner rig thermal proof test.

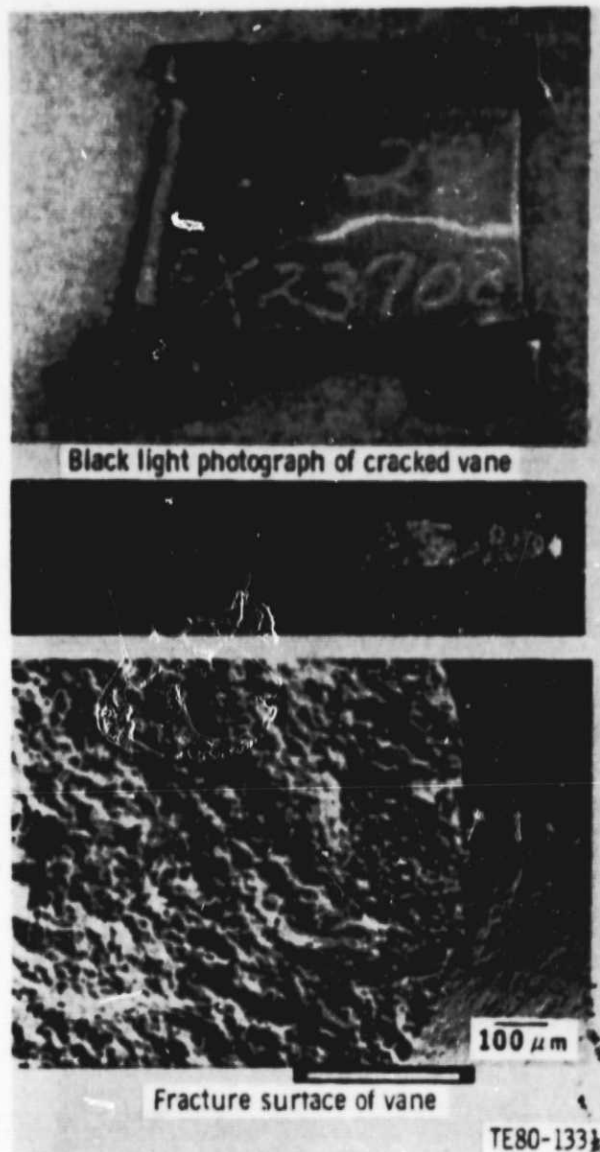
Figure 81. Failed reaction-bonded silicon carbide vane FX23708 from burner rig thermal proof test.

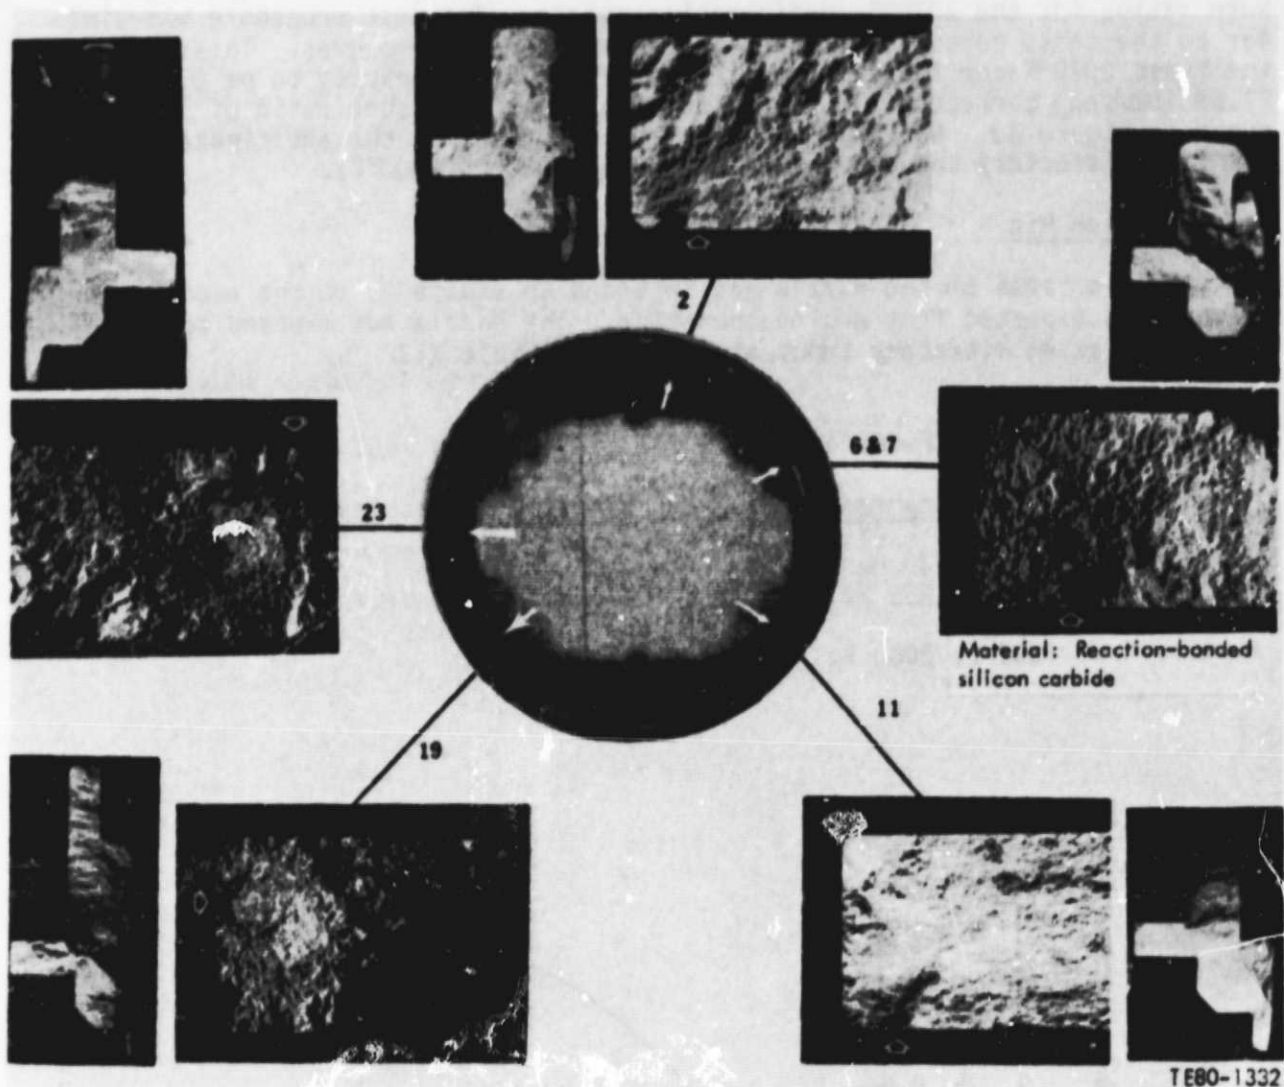
Examination of the vane inner support ring showed it to be broken in five locations. The fractures are close to vane pockets 354 deg, 302 and 289 deg, 238 deg, 135 deg, and 89 deg CW VFR as indicated in Figure 82. Among these fractures, three (354 deg, 302 and 238 deg, and 135 deg) started at the rear ID of the ring, one (135-deg CW VFR) at ID, and one (89-deg CW VFR) near the front corner at ID. All failure origins are free of any obvious defects, and their locations are coincident with the location of calculated maximum principal thermal stress of approximate 90 MPa (13.0 ksi).

Furthermore, no microstructural abnormalities were found in the flange area. Therefore, at present no causative agents that could account for the failure of the inner support structure have been identified. The predicted stresses in this flange were no more than 117 MPa (17 ksi). MOR test bars cut from the qualification billet of the fractured ring indicated a material strength of

Figure 82. Fracture surface associated with failure location found on the inner support structure (arrows indicate failure origins at vane pocket numbers).

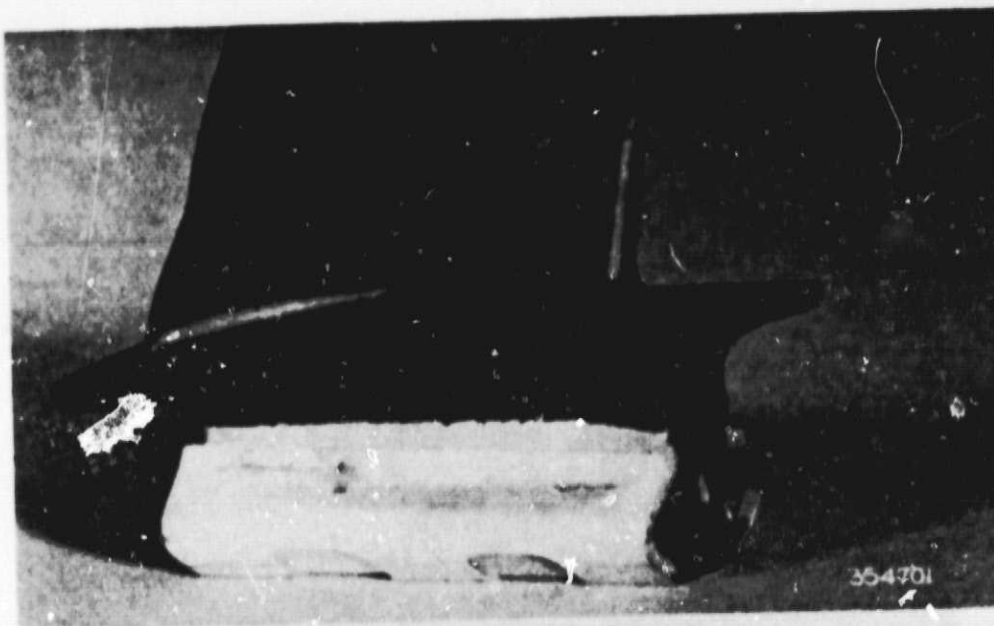
Compliant layer and blade condition  
after spin to 37,000 rpm (100.3%)

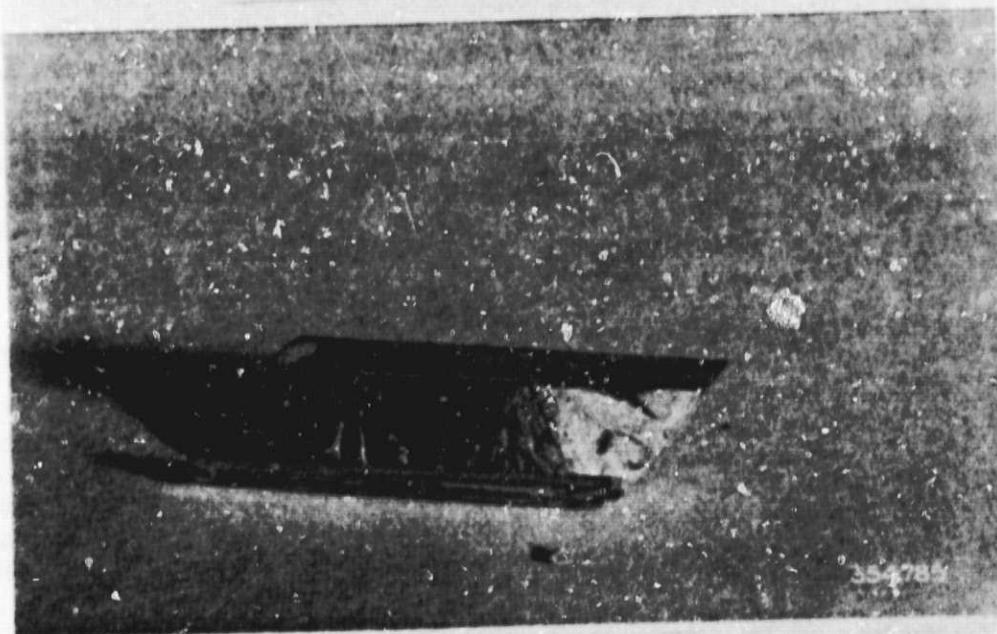
Failure initiation site  
failed at 47,500 rpm (128.7%)

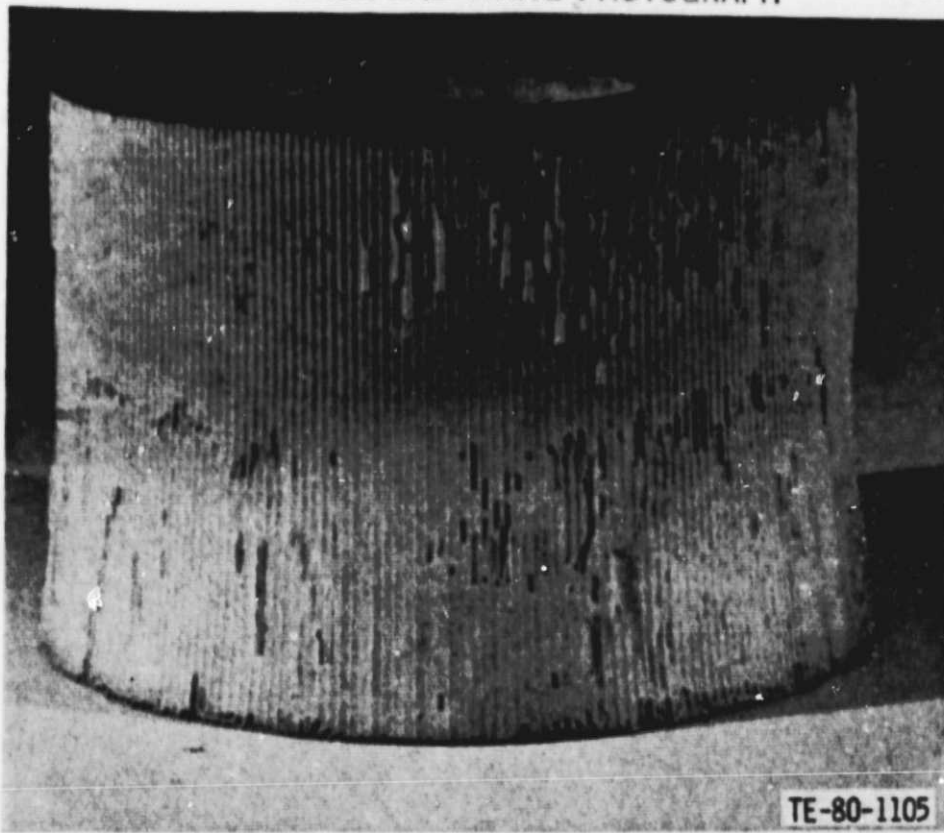
Figure 100. Hub broken out of bus ceramic regenerator disk.

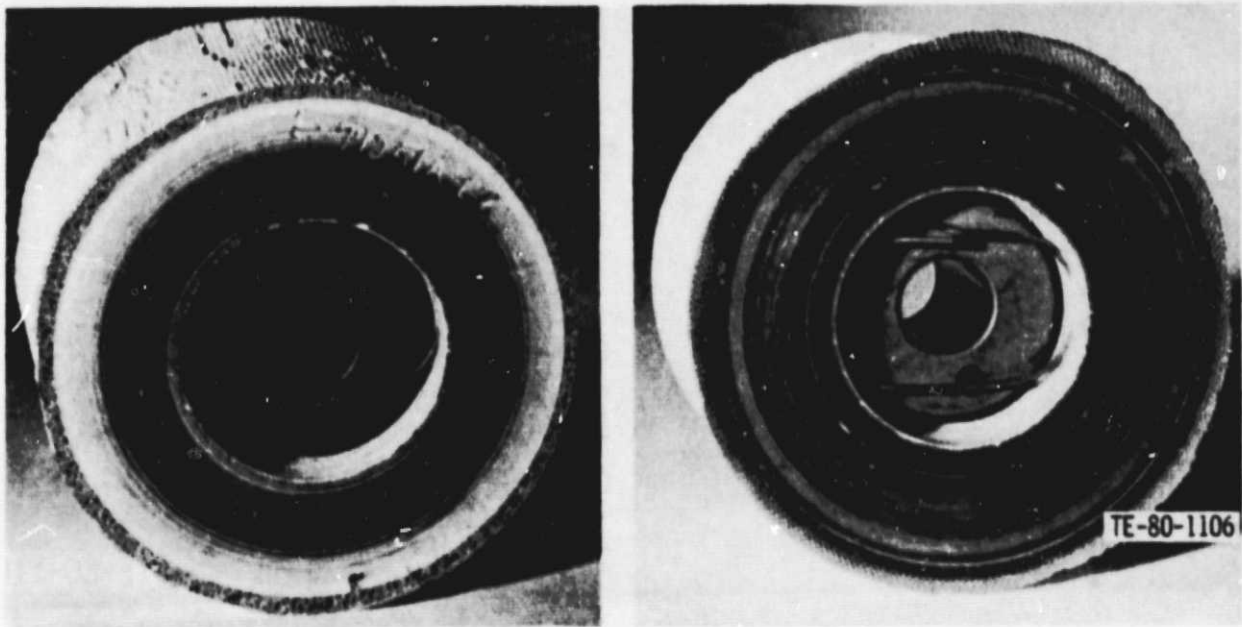
Figure 101. Hub broken out of bus ceramic regenerator disk.

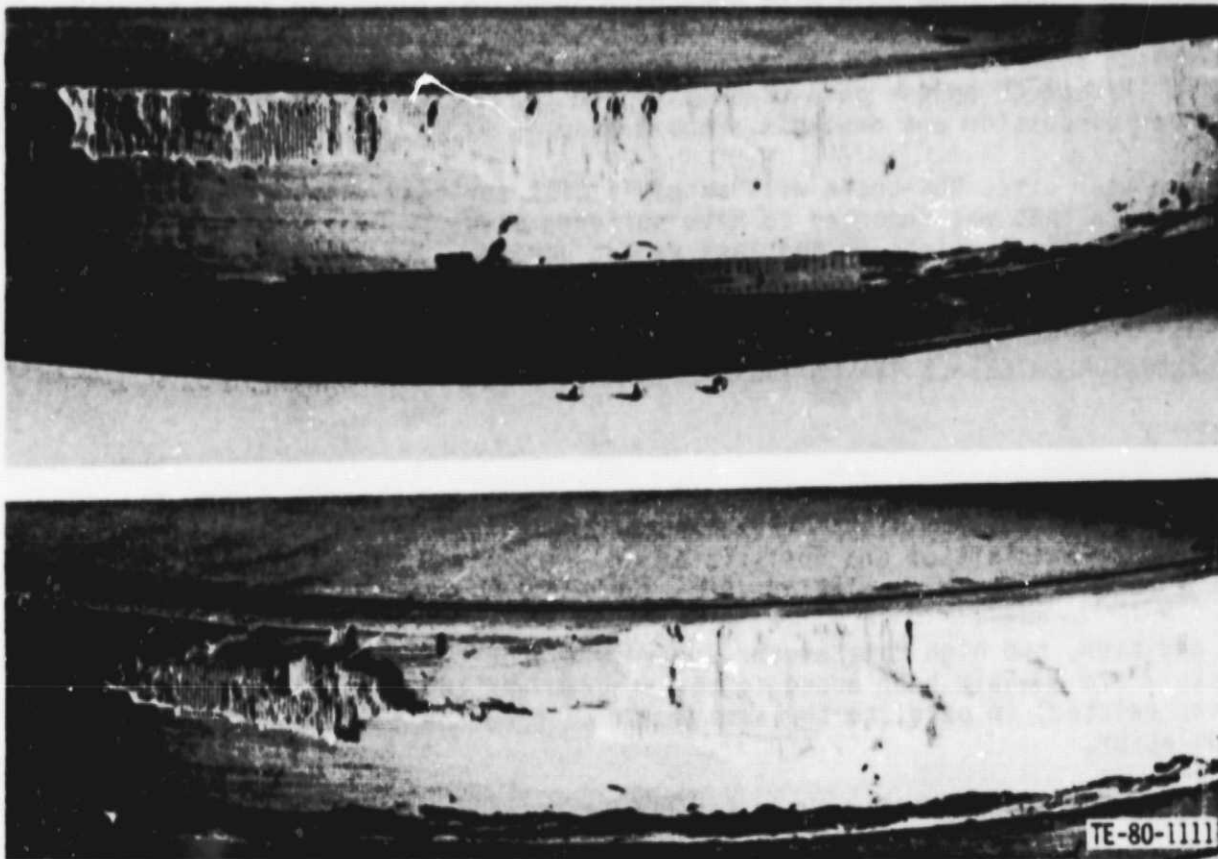
Figure 105. Damage caused to disk GM15-14 by heads of rivet type B.
